**CARTER MANUFACTURING CO., INC.**

PART NAME: ASSEMBLY

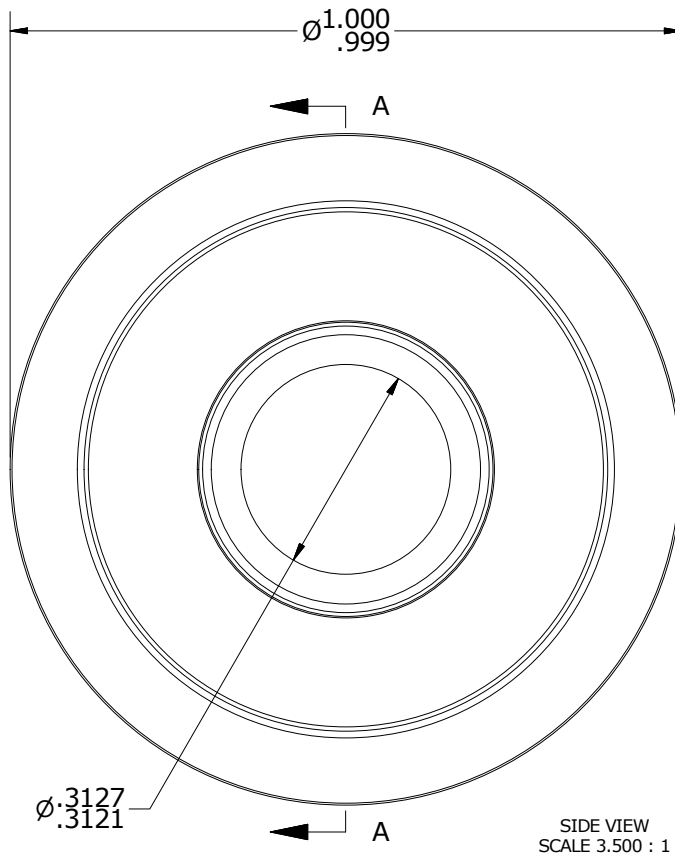
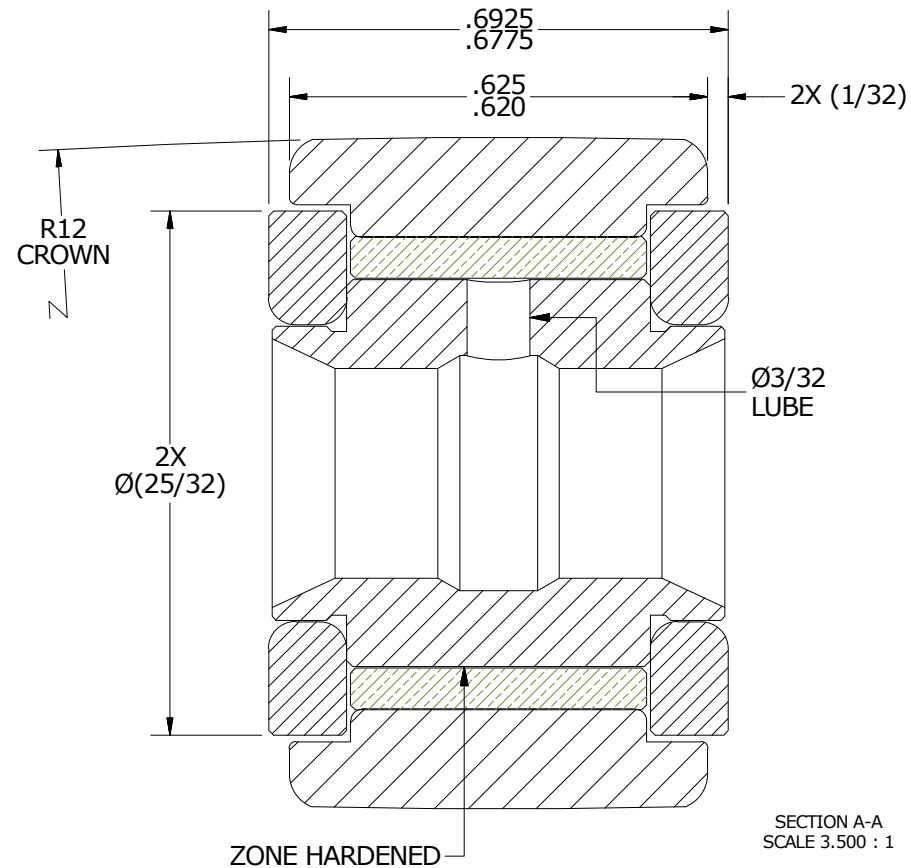
1. BUSHING IS IMPREGNATED WITH OIL
2. ALL EXPOSED STEEL SURFACES HAVE BLACK OXIDE

OUTER RING - BEARING STEEL, HEAT TREATED  
INNER RING - BEARING STEEL, ZONE HARDENED  
BUSHING - SINTERED BRONZE  
WASHER(S) - BEARING STEEL, HEAT TREATED\*\*
