CARTER MANUFACTURING IS NOT RESPONSIBLE FOR TYPOGRAPHICAL ERRORS		CARTER MANUFACTURING CO., INC. GRAND HAVEN, MICHIGAN 49417			
REVISION		PART NAME: ASSEMBLY			
A	AUTHOR BY HG	DRAWN BY SGW	CHK'D BY MD	SALES KR	MATERIAL NOTED
REVISION BY SGW	DATE 11/10/2016	DATE 11/8/2016	DATE 11/9/2016	DATE 11/11/2016	SHEET 1 OF 2

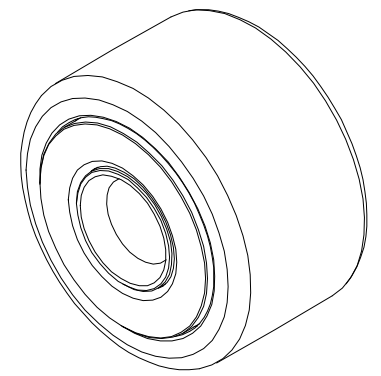
ISO VIEW
 SCALE 1.125 : 1

- NOTES:
 1. BUSHING IS IMPREGNATED WITH OIL
 2. ALL EXPOSED STEEL SURFACES HAVE BLACK OXIDE

MATERIAL NOTES:
 OUTER RING - BEARING STEEL, HEAT TREATED
 INNER RING - BEARING STEEL, ZONE HARDENED
 BUSHING - SINTERED BRONZE
 WASHER(S) - COLD ROLLED STEEL, HEAT TREATED*

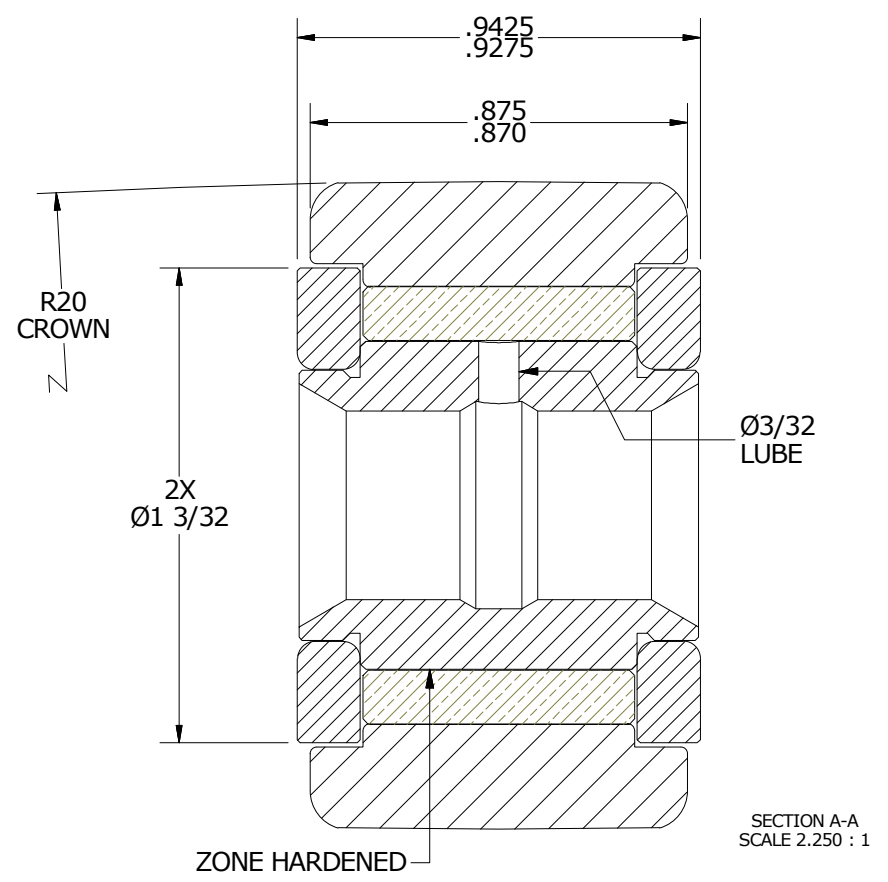
*(DEPENDING ON MATERIAL AVAILABILITY, MAY BE CONSTRUCTED FROM BEARING STEEL)
