CSFH-40-A

DRAWING NO.

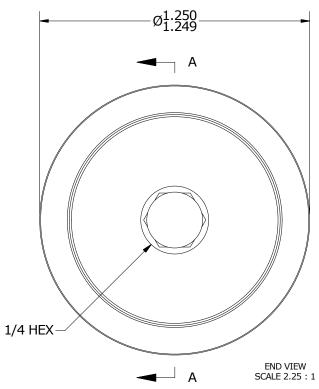
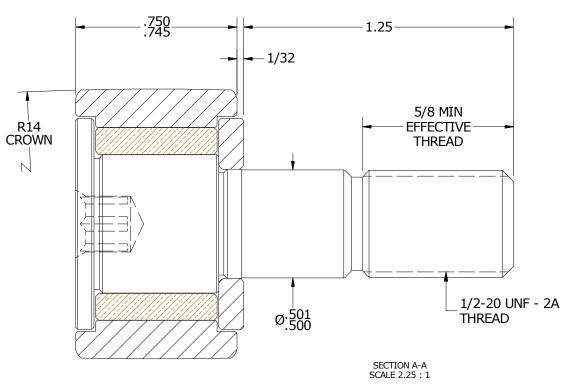
ISO VIEWS SCALE 1.125: 1

1. BUSHING IS IMPREGNATED WITH OIL

2. ALL EXPOSED SURFACES HAVE BLACK OXIDE
