NYR-112

CARTER MANUFACTURING CO., INC.

PART NAME: ASSEMBLY

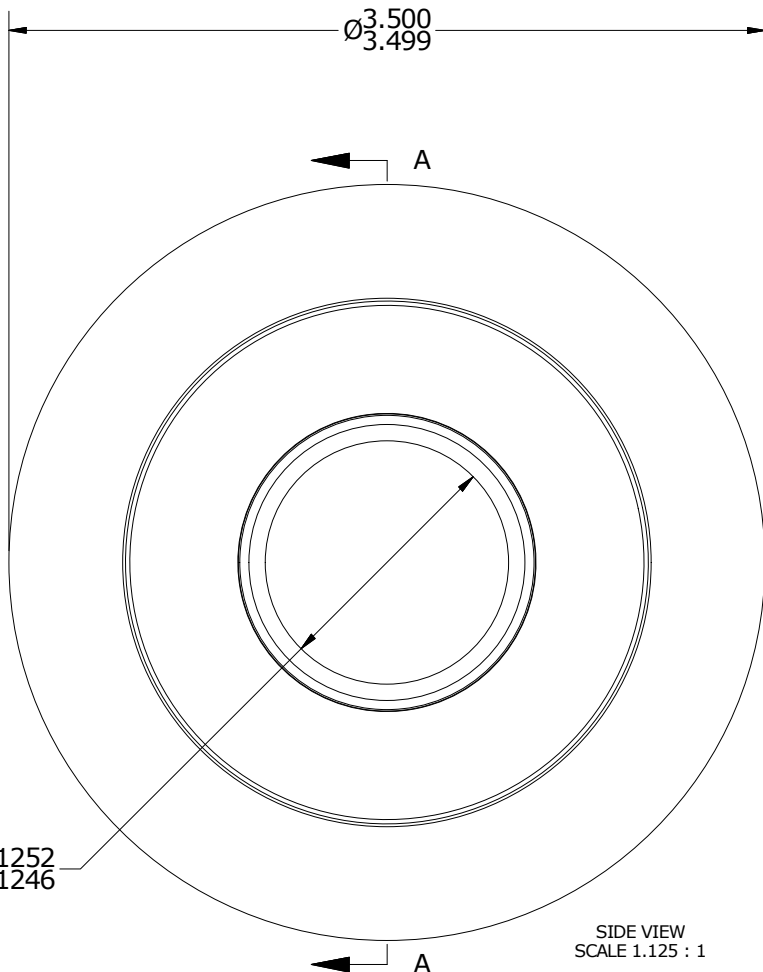
SIDE VIEW
 SCALE 1.125 : 1

OUTER RING - BEARING STEEL, HEAT TREATED
 INNER RING - BEARING STEEL, ZONE HARDNED
 WASHERS - COLD ROLLED STEEL, HEAT TREATED
 BUSHING - SINTERED BRONZE

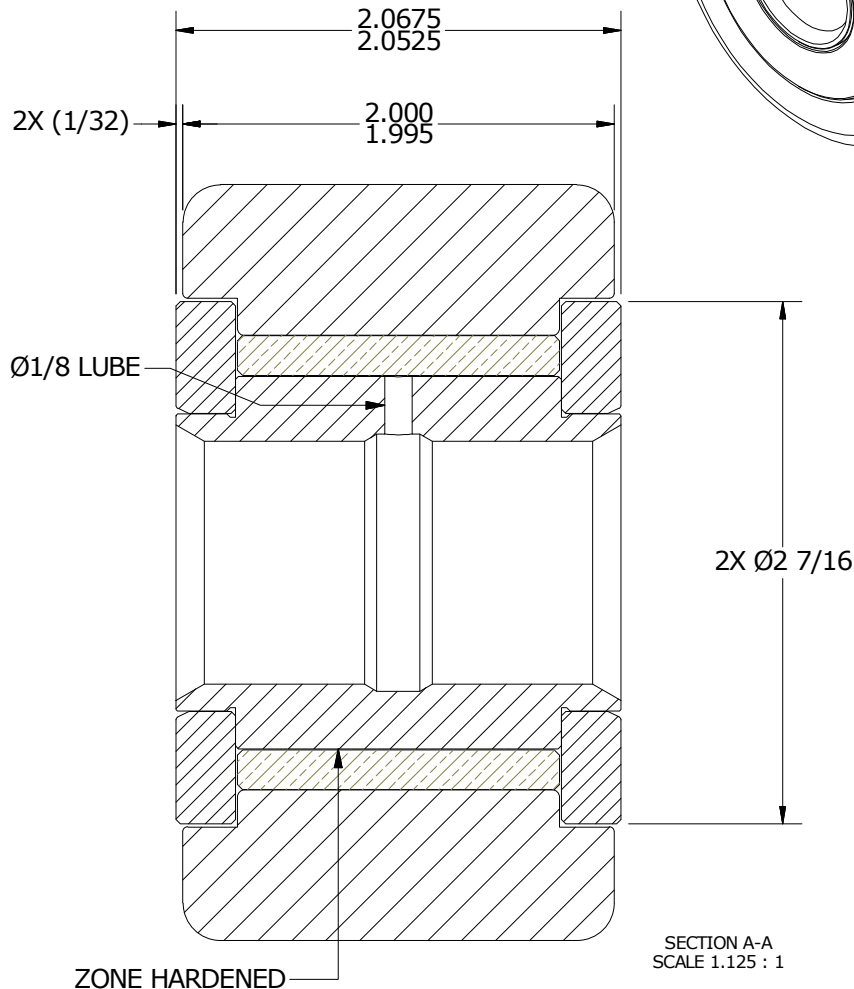
SECTION A-A
 SCALE 1.125 : 1

- NOTES:
 1. BUSHING IS IMPREGNATED WITH OIL
 2. ALL EXPOSED STEEL SURFACES HAVE BLACK OXIDE
