CARTER MANUFACTURING CO., INC.

PART NAME: ASSEMBLY

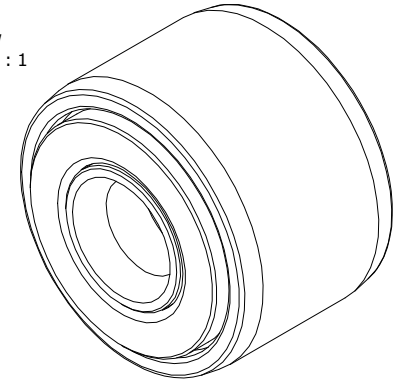
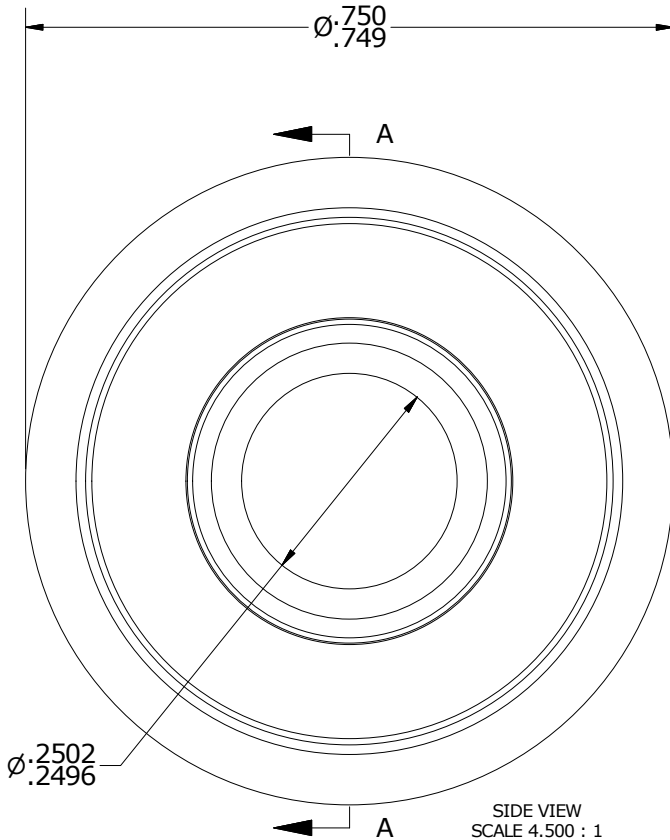
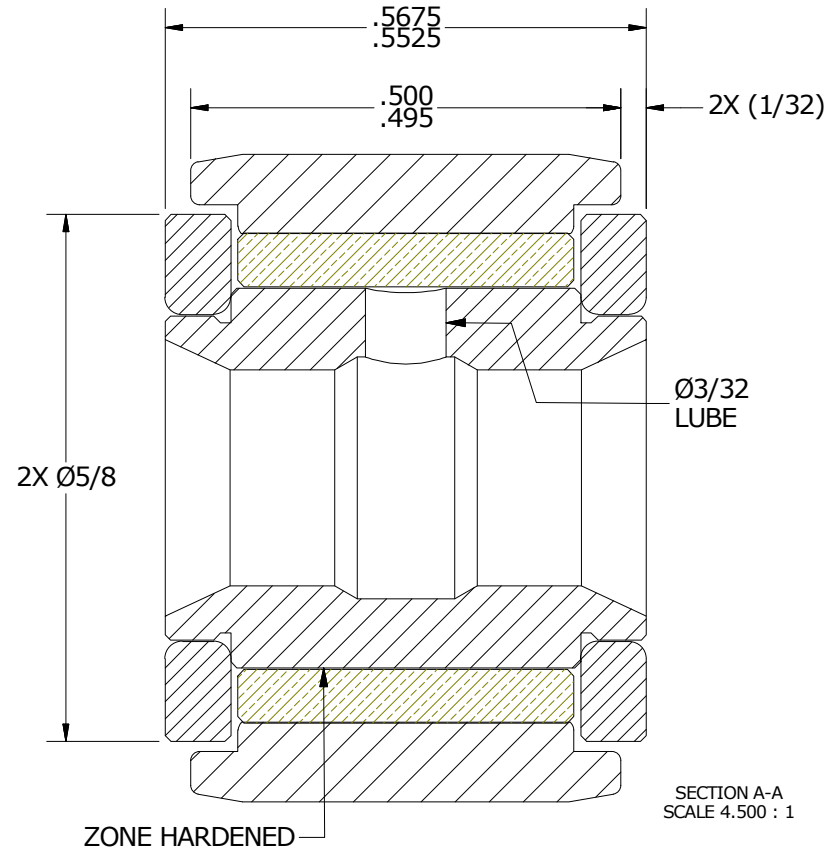
ISO VIEW
SCALE 2.250 : 1

1. BUSHING IS IMPREGNATED WITH OIL
2. ALL EXPOSED STEEL SURFACES HAVE BLACK OXIDE

OUTER RING - BEARING STEEL, HEAT TREATED
INNER RING - BEARING STEEL, ZONE HARDENED
BUSHING - SINTERED BRONZE
WASHER(S) - BEARING STEEL, HEAT TREATED
