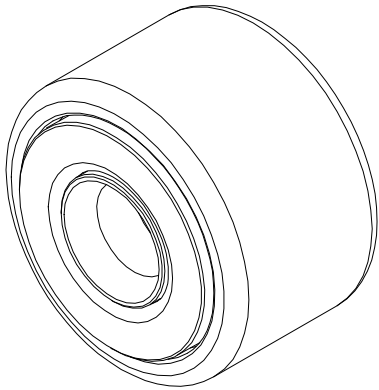
ISO VIEW
SCALE 1.750 : 1

- NOTES:
- 1. BUSHING IS IMPREGNATED WITH OIL
 - 2. ALL EXPOSED STEEL SURFACES HAVE BLACK OXIDE

OUTER RING - BEARING STEEL, HEAT TREATED
INNER RING - BEARING STEEL, ZONE HARDENED
BUSHING - SINTERED BRONZE
WASHER(S) - BEARING STEEL, HEAT TREATED
