CUSTOMER PART#	XX = ± .01 XXX = ± .005 XXXX = ± .0005 ANGLES = ± 1' INCH [METRIC] FRACTION = ± 1/32		CARTER MANUFACTURING IS NOT RESPONSIBLE FOR TYPOGRAPHICAL ERRORS		CARTER MANUFACTURING CO., INC. GRAND HAVEN, MICHIGAN 49417			
	ENGINEERING CHANGE ORDER NOTE		REVISION		PART NAME: ASSEMBLY			
			C	AUTHOR BY HG	DRAWN BY JAF	CHK'D BY MD	SALES KR	MATERIAL NOTED
			REVISION BY SGW	DATE 11/10/2016	DATE 8/15/2006	DATE 11/9/2016	DATE 11/11/2016	SHEET 1 OF 2

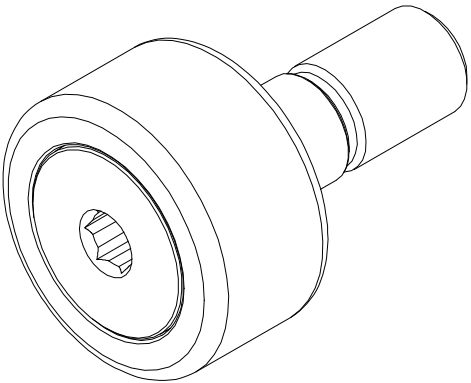
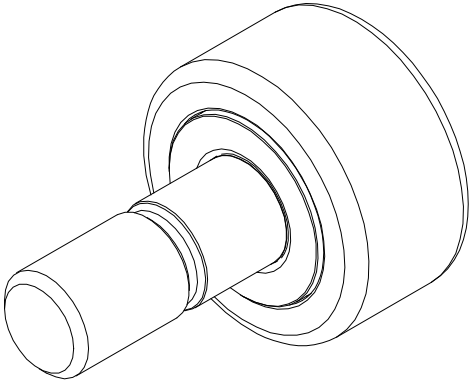
ISO VIEWS
SCALE 1 : 1

- NOTES:
- 1. BUSHING IS IMPREGNATED WITH OIL
 - 2. ALL EXPOSED SURFACES HAVE BLACK OXIDE

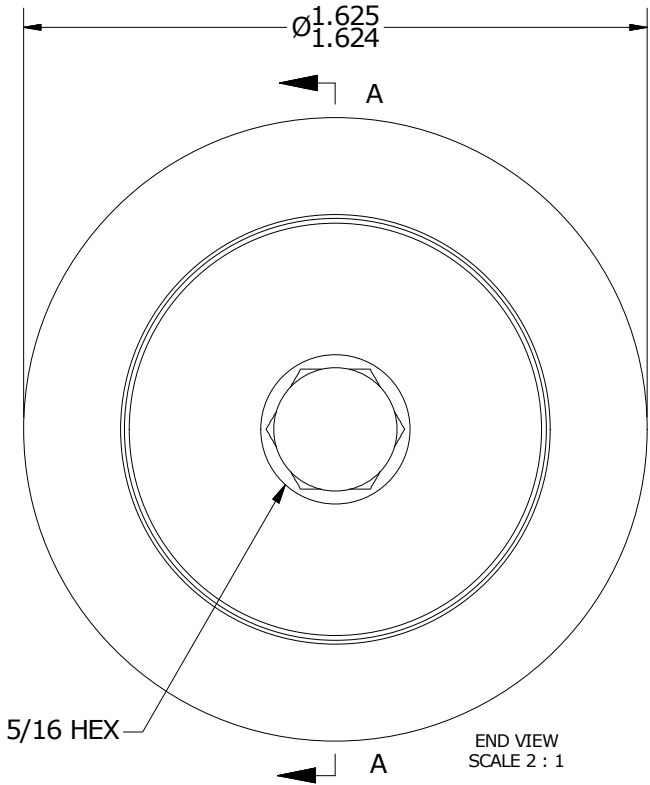
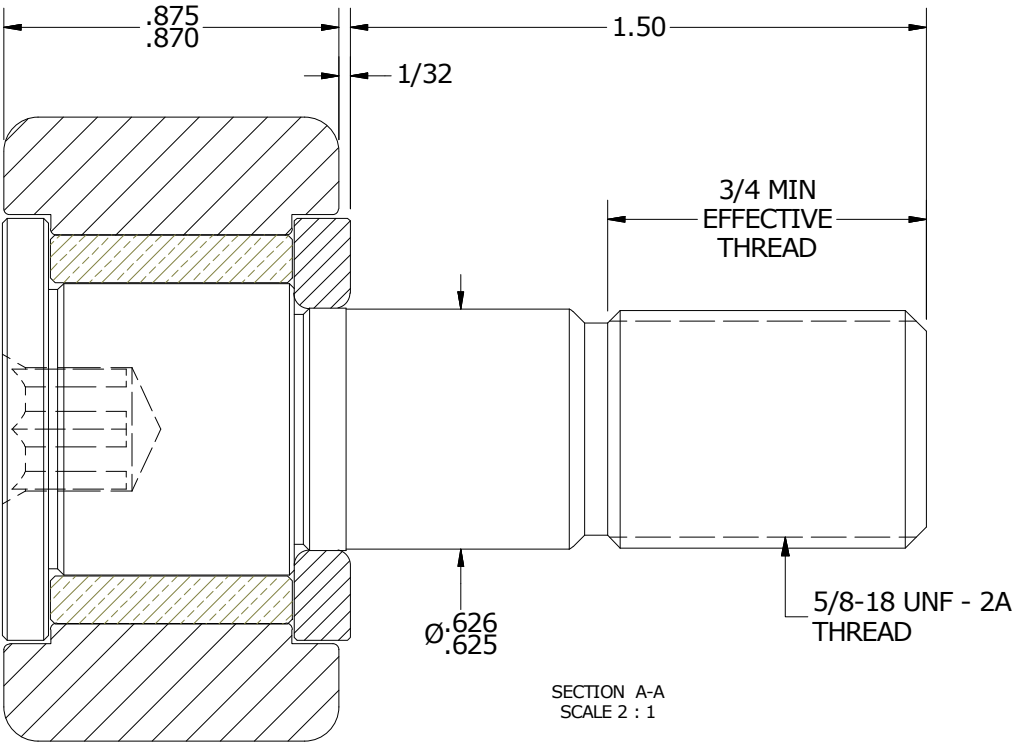
SECTION A-A
SCALE 2 : 1

MATERIAL NOTES:

OUTER RING - BEARING STEEL, HEAT TREATED
STUD - COLD ROLLED STEEL
WASHER - BEARING STEEL, HEAT TREATED*
BUSHING - SINTERED BRONZE

*(DEPENDING ON MATERIAL AVAILABILITY MAY BE CONSTRUCTED FROM COLD ROLLED STEEL)
