SFHE-16-A

CUSTOMER PART#	$\begin{array}{c} XX = \pm .01 \\ XXX = \pm .005 \\ XXXX = \pm .0005 \\ ANGLES = \pm 1 \\ INCH [METRIC] \\ FRACTION = \pm 1/32 \end{array}$	CARTER MANUFACTURING IS NOT RESPONSIBLE FOR TYPOGRAPHICAL ERRORS		CARTER MANUFACTURING CO., INC. GRAND HAVEN, MICHIGAN 49417			
			REVISION		PART NAME: ASSEMBLY			
	ENGINEERING CHA	ANGE <u>O</u> RDER NOTE	Λ	AUTHOR BY	DRAWN BY	CHK'D BY	SALES	MATERIAL
			А	HG	SGW	MD	KR	NOTED
			REVISON BY	DATE	DATE	DATE	DATE	SHEET
			SGW	8/1/2017	8/1/2017	8/1/2017	8/1/2017	1 OF 2

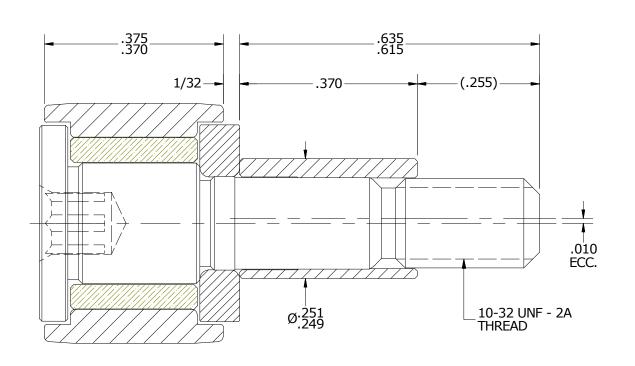
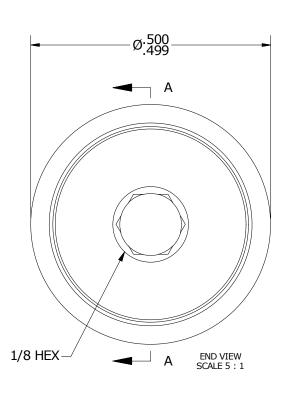
SECTION A-A SCALE 5 : 1

- BUSHING IS IMPREGNATED WITH OIL
 ALL EXPOSED SURFACES HAVE BLACK OXIDE

OUTER RING - BEARING STEEL, HEAT TREATED STUD - COLD ROLLED STEEL WASHER - BEARING STEEL, HEAT TREATED

BUSHING - SINTERED BRONZE

ECCENTRIC SLEEVE - COLD ROLLED STEEL
